⚠️ FACEL-VEGA V8 STEERING SAFETY NOTICE

PITMAN ARM FAILURE

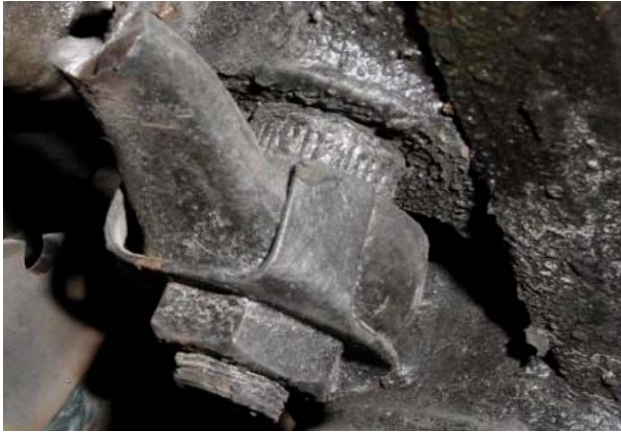
On November 3, 2006, an FV4 owner was pulling out of a parking lot at low speed when he completely lost his steering. Luckily, he stopped the car, got the car towed to a shop, no damage or injury. The car has the original Facel power steering system. The primary Pitman arm broke near the joint:

FV4 Pitman arm, broken while driving

Rust in the fracture shows that the Pitman arm was cracked on both the top and bottom before it failed. These cracks appear to be the result of vertical up and down forces on the Pitman arm.

Remedy: If your Facel has the original power steering, this item needs to be removed and magnafluxed by a specialist. If there are any cracks, replace the item. Hans Ruhe of Holland has offered to make a new heavy duty FV/HK500/Excellence Pitman arm if there is sufficient interest. Contact him for details.

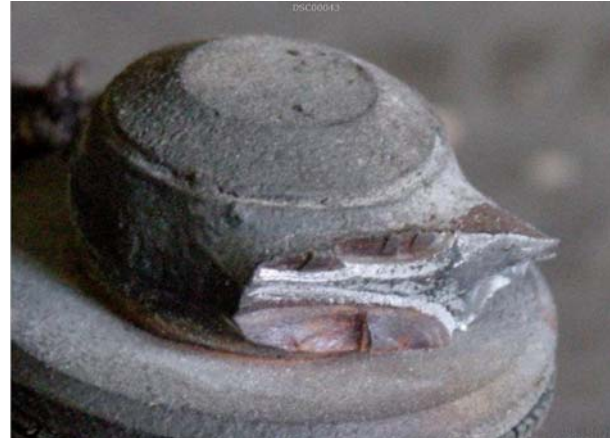
Close-up of FV4 Pitman arm break near joint

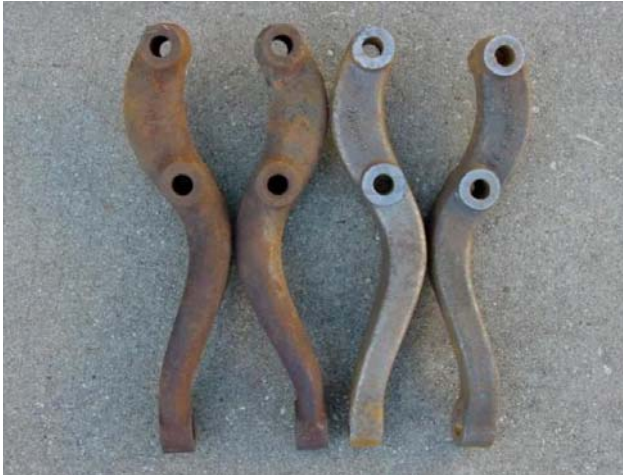
- Approx. 1985 - USA, driving an HK500, steering arm failure. Upon inspection, both his steering arms had failed previously and had been welded!
- There have been several other cases of steering arm failure reported.

Steering arms - original left; new H.D. right

Remedy: If you have a V8 Facel, replace the original steering arms with heavy duty steering arms made with modern materials and forging techniques. These heavy duty arms are available from Hans Ruhe of Holland and Jurgen Kromer of Germany.

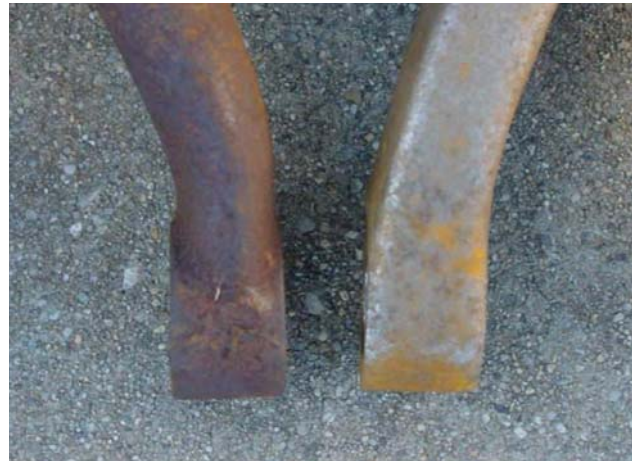
Steering arms - original left; new, strong H.D. right

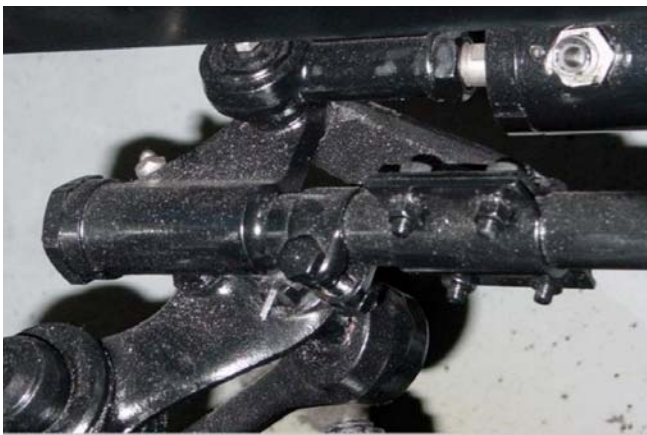
In each case of failure, the support brace had either not been added or had been removed and not replaced during servicing. Facel issued Service Bulletin #11 to install a support brace on the center rod. See the service bulletin for details. (Note: This does not apply to Facel II/HK2 models)

Center rod support brace, attached with 4 bolts

Remedy: If your V8 Facel has the original power steering as shown in Service Bulletin #11 and does not have this support brace, replace the center rod with a new rod and install the support brace. The center rod and support brace may be available from Hans Ruhe of Holland or Jurgen Kromer of Germany.

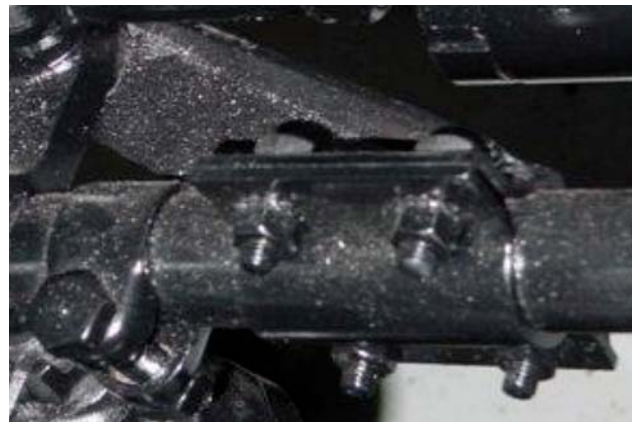
Close-up of support brace
